Samuel McKenzie House
Avilton
Private

ca.1840

INVENTORY FORM FOR STATE HISTORIC SITES SURVEY 1-32-885404

Samuel McKenzie House

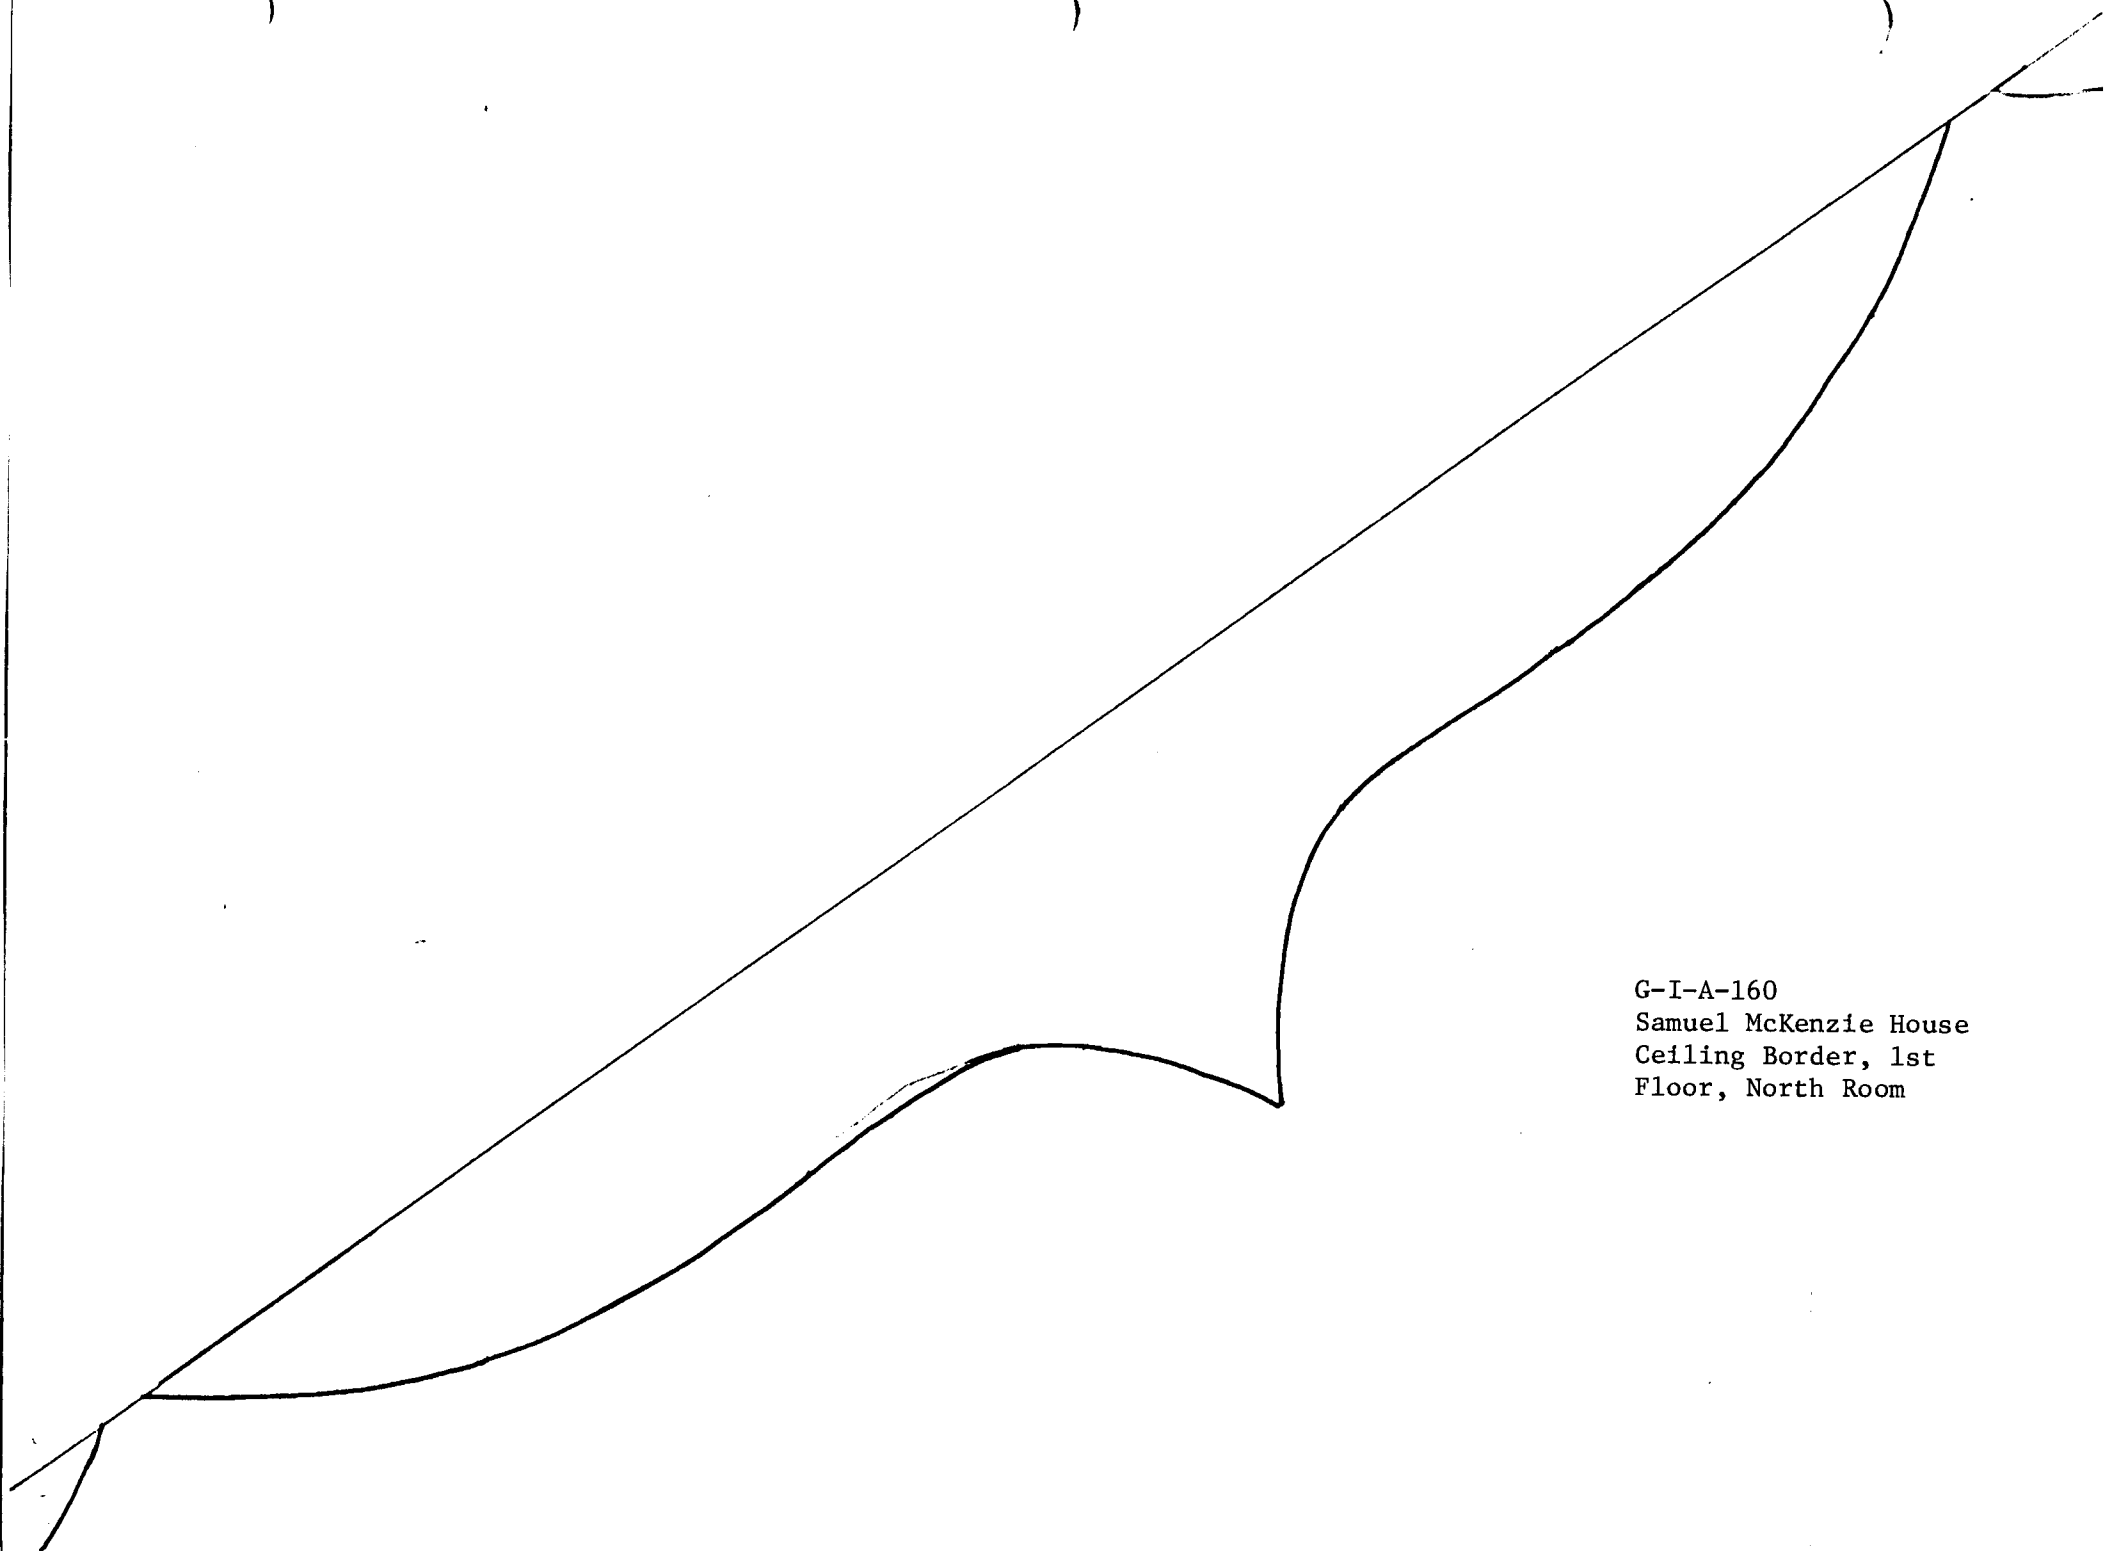
G-I-A-160
Samuel McKenzie House
Ceiling Border, 1st
Floor, North Room

The walls in the first floor, north room are paneled with horizontal, random width, beaded board. A beaded chair rail surrounds the room on all walls but the partition wall. At the corners of the room the chair rails overlap, the base of one touching the top of the other, so that they are fixed to the walls at differing heights rather than being mitred together at the same level. Random width, flat boards line the ceiling. A flimsy partition wall made of studs covered with corrugated cardboard and wallpaper, was installed in this room in the mid-twentieth century to create a front and a back room out of this space.

Due to the application of many layers of wallpaper over the years, the original paint colors and ornamentation in this room have been preserved underneath. The chair rails are painted pale blue, the wall area above it is light green, and the lower wall is black with a subsequent layer of deep yellow-gold. The ceiling's color is a very dark blue-green. A scalloped border painted just below the ceiling is the same blue-green color. Rather than stenciling the scalloped border, lines were drawn on the wall, then painted in. The partition wall is painted in the same color scheme as the other walls, however, since it has no actual chair rail, a dark blue-green chair rail was painted on, down to the fine detail of depicting the beaded edge that distinguishes the real chair rail.

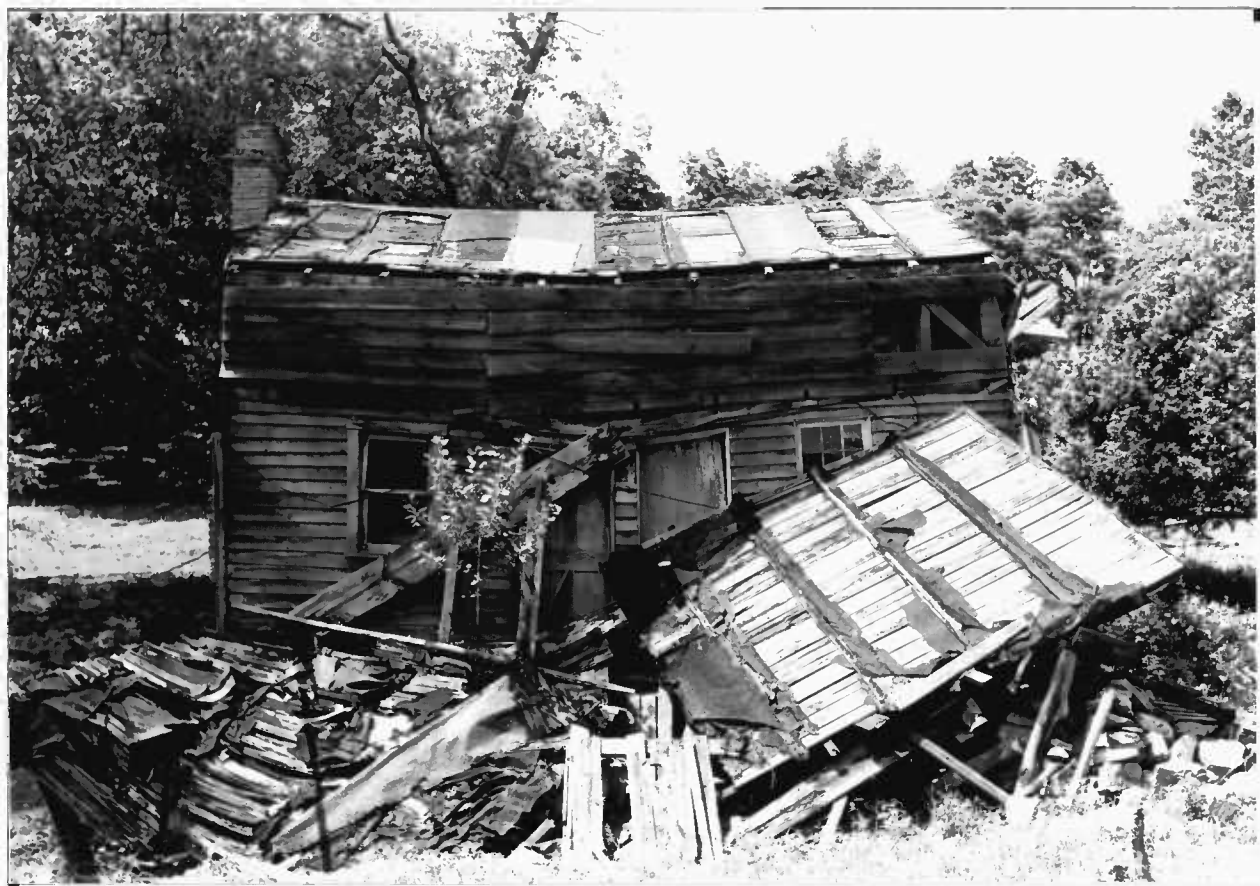
FIGURE 91

The facade (E elevation) has a symmetrical, four bay arrangement with two center doors spaced very close together, and a window on each side. The northern door is board and batten, while the southern one is a raised, four-panel door. A 6/6 sash window pierces the northern end of the wall. This window and both doors are without surrounds. The southern window, a 1/1 sash, has a plain board surround and a molded dripboard. The upper level of the facade is unfenestrated because the porch that formerly stretched across this elevation was an extension of the roof from the main block, and fully masked this upper portion of the wall. According to a 1920 photograph of the house¹; the southern half of the porch was enclosed, sided with weatherboard, and lit by a small window on its east side. The open area of the porch was supported by two posts with a baluster railing on the east edge, and two steps leading up to the north side. The roofline was continuous from the ridge to the cornice of the porch. Recently, the porch has fallen away from the house and its dry-laid, split stone foundation has tumbled.

Facade - E elevation

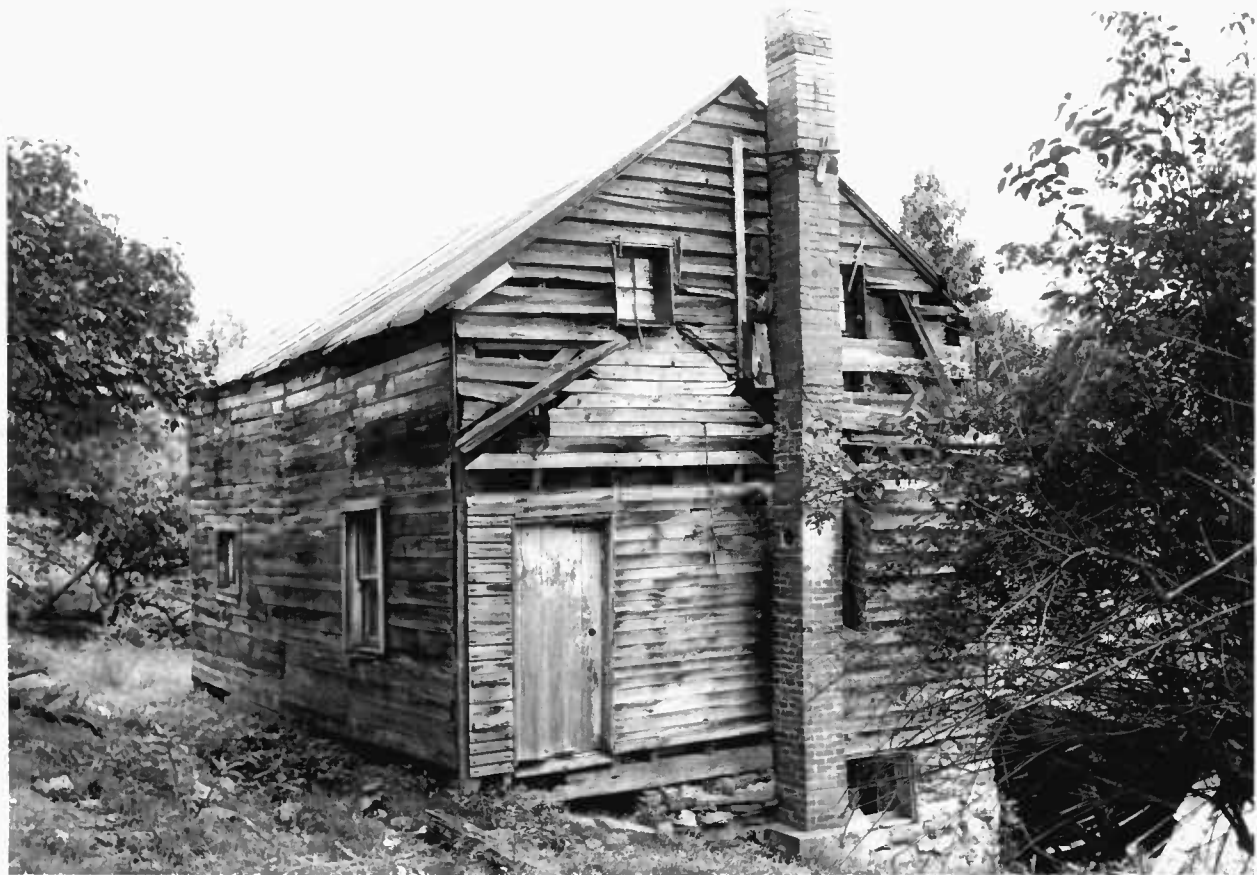
FIGURE 91

A board and batten door occupies the extreme western end of the south endwall. Two four-pane casement windows pierce the gable. Scars on the siding reveal the outlines of a one story, gable-roofed wing that projected from the western half of this wall, encompassing the door and a brick stove chimney on a concrete base.

The rear (W elevation) is pierced by two windows at the ground level: a 1/1 sash at the southern end, and a small, square, single pane fixed window at the northern end.

Rear - W & S elevations
